EAST STROUDSBURG DAM

PHASE I INSPECTION REPORT NATIONAL DAM INSPECTION PROGRAM

NDS I.D. NO. PA 00637
DER I.D. NO. 45-155

East Stroudsburg Dam. NDS ID PA-00637.
DER ID-45-155. Delaware River Basin.
Sambo Creek, Monroe County, Pennsylvania.
Phase I Inspection Report.

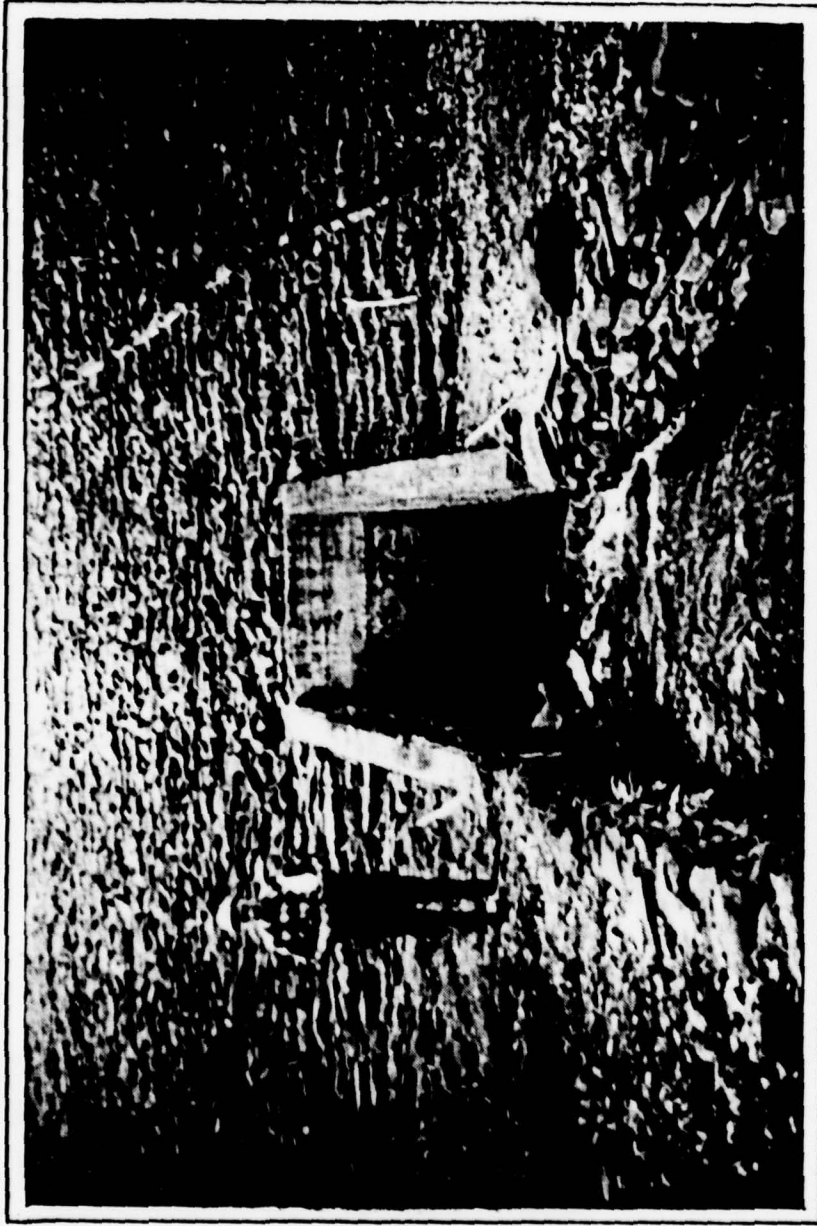
PHOTOGRAPH NO. 1

The intake and outlet pipes are embedded in the embankment and could not be inspected. The outlet structure at the downstream toe was judged to be in good condition. The outlet channel below the dam was also judged to be in good condition.

OUTLET OF DISCHARGE PIPE.

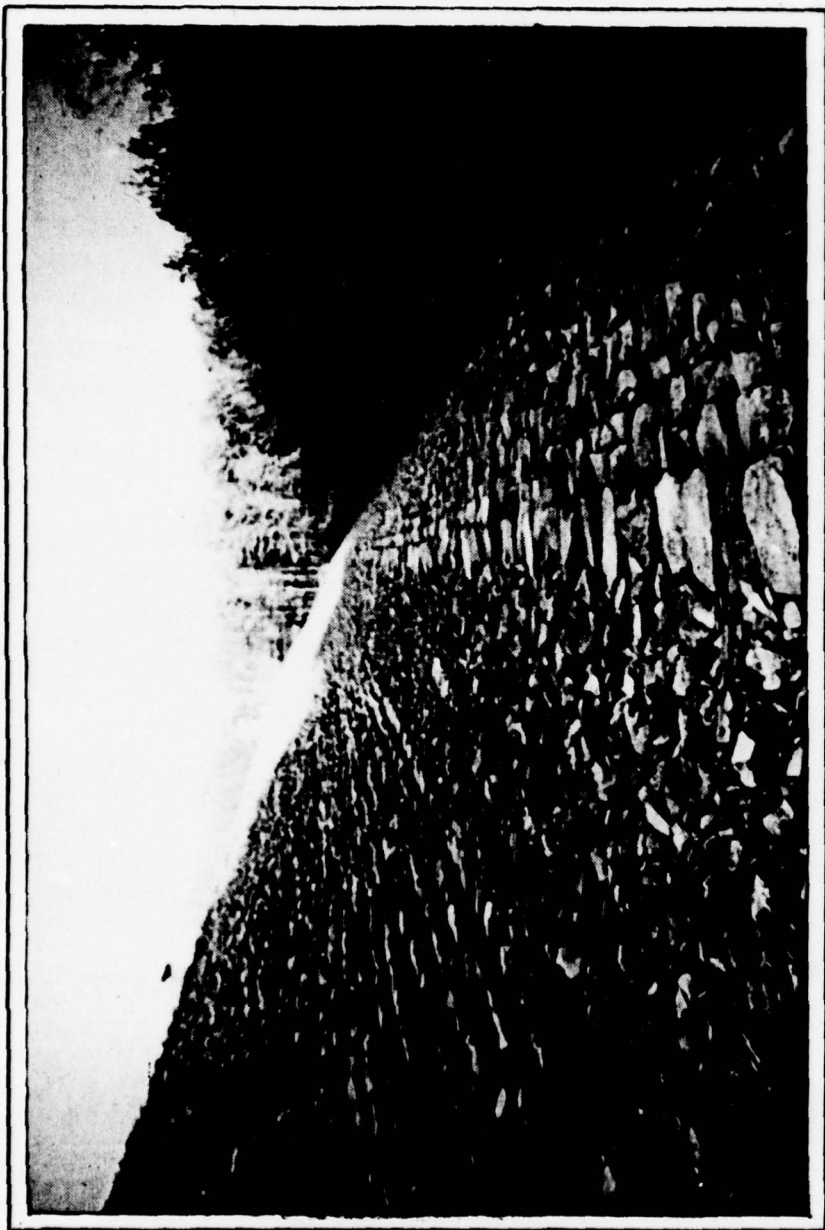
PHOTOGRAPH NO. 8

OVERVIEW OF DOWNSTREAM SLOPE.

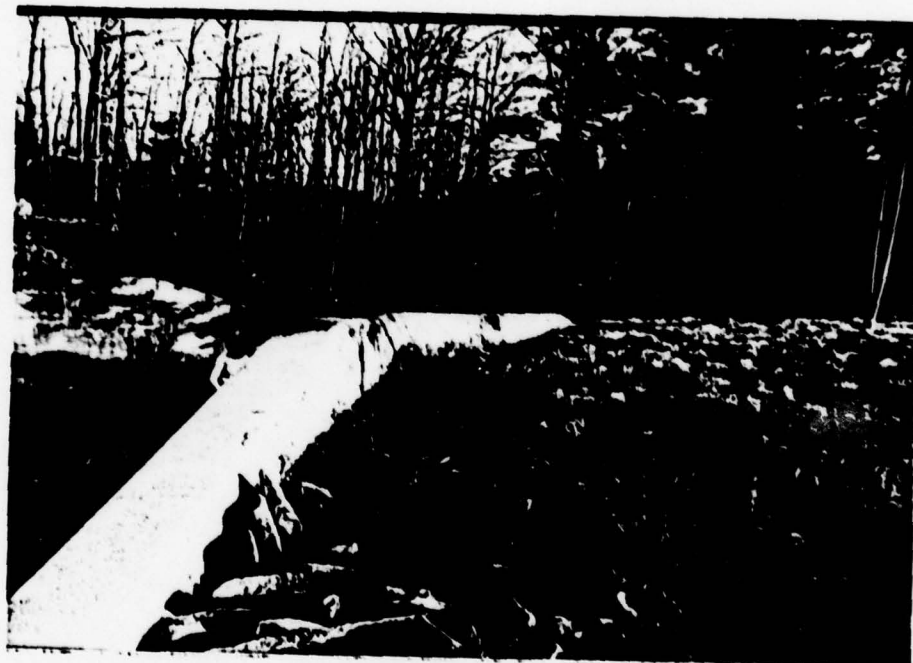
PHOTOGRAPH NO. 16

The junctions between the abutments and the embankment were inspected and evaluated to be in good condition. The junction between the abutment and the spillway was inspected and settlement of 12 to 14 inches was noted, as shown on Photograph 16. This reduces the storage capacity of the reservoir.

Photograph No. 16 shows the relatively large amount of settlement adjacent to the spillway wall. This settlement reduces the maximum reservoir level and, therefore, the spillway capacity. Other observations regarding the condition of the downstream channel, spillway and reservoir are located in Appendix B.

Calculations for this investigation estimate the spillway discharge to be about 1,744 cfs with the reservoir at the top of the spillway wall. Under existing conditions, settlement adjacent to spillway wall, the spillway discharge is reduced to about 1,160 cfs. The HEC-1 program computed the peak PMF inflow to be about 4,000 cfs. As shown in Appendix C, the spillway can pass about 0.48 PMF under existing conditions and about 0.62 PMF with an embankment elevation of 893.6, the minimum crest elevation excluding settlement adjacent to the spillway wall.

DEPRESSION IN EMBANKMENT
ADJACENT TO LEFT SPILLWAY
WALL.
